Aviation Safety

Ultralight and Balloon

Issue 1/2001

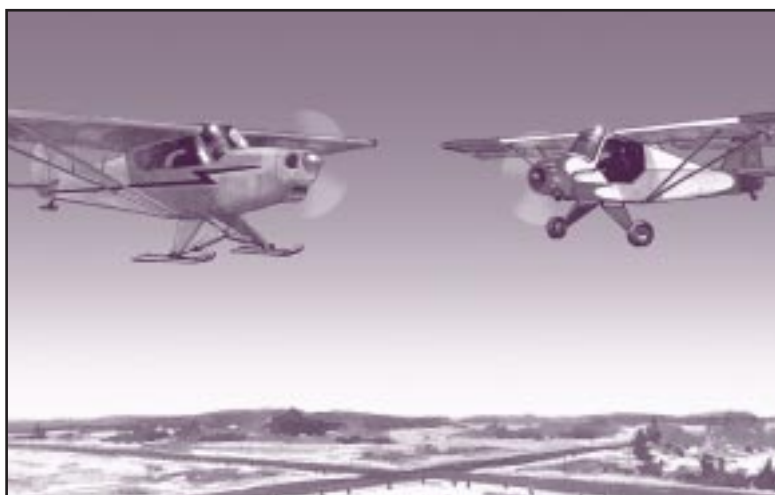
The pilot of a Piper PA-18-150 Super Cub had just departed his private strip in Mattawa, Ontario, in good VFR visibility conditions. He intended to do a couple of local circuits alone as a first flight after having recently installed skis. He was to depart later with a passenger to visit a nearby fishing camp. After takeoff, the pilot flew circuits over the southwest area of the town. Simultaneously, the pilot of a Kitfox IV/A was flying local VFR circuits. The Piper Super Cub was observed flying northeasterly towards the town and the Kitfox was observed flying southwesterly over the town when the two aircraft collided over Sid Turcotte Park.

This is a worst case interception of about 90° to each other and possibly at the same altitude in level flight. This could have been prevented if one or both pilots were maintaining a scan that included good head movement to observe targets in blind spots, such as behind door posts, as would have been applicable in this case. The collision angle fosters speculation that both were stationary targets near or behind a door post or window post and thus both remained invisible to each other until the collision. I could list numerous cases of this near airport/local flying type of mid-air collision; however, I would like to focus on avoidance. There are several tools that pilots can use for local separation, including radios, prior discussions, landing lights or, in the case of ultralights, the spotlight, pre-flight briefing with other area pilot or pilots doing simultaneous flights in a particular area and, last but not least, using proper procedures around airports. —Ed.

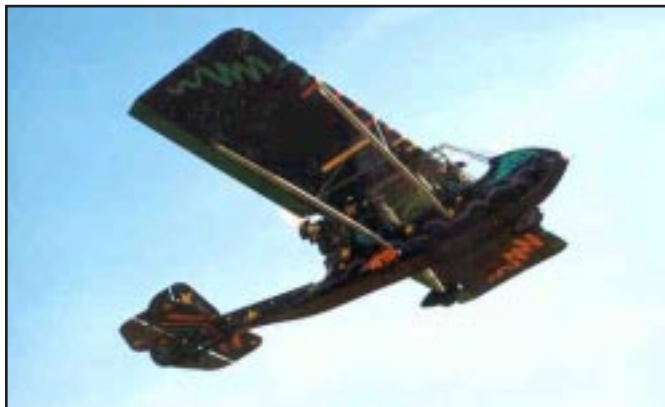
Challenger similar to the aircraft described in this letter.

In conclusion, I have made the following observations, which I believe, in combination with a dirty air filter, to be the reason for the engine failure.

- 1) I had not re-primed the fuel lines after completely draining the float bowls.
- 2) The fuel pump supplied by the factory had a little bleed hole to allow moisture to escape because of the conditions they are subjected to on snowmobiles. This allows air to be drawn into the crankcase and leans the mixture as well as reduces the vacuum pressure to the fuel pump. It should be noted that these fuel pumps are designed to run with a flooded suction or a very short (six inches) lift. In the Challenger, the lift that the pump is required to perform is 15 to 24 in. depending on fuel levels in the tank.

- 1) Silver soldered the bleed hole in the vacuum line closed.
- 2) Removed the primer squeeze bulb and replaced it with a secondary electrical fuel pump.
- 3) Replaced the hose from the crankcase to the fuel pump with a braided hose.
- 4) Revised the checklist to include priming the fuel lines.
